# Service Bulletin

Bulletin No.: PIT5273

**Subject:** 5th Wheel Or Camper Wiring Harness Location

**Models:** 2015 Chevrolet Silverado  
2015 GMC Sierra  
With 5th Wheel / Camper Harness (RPO UY2)

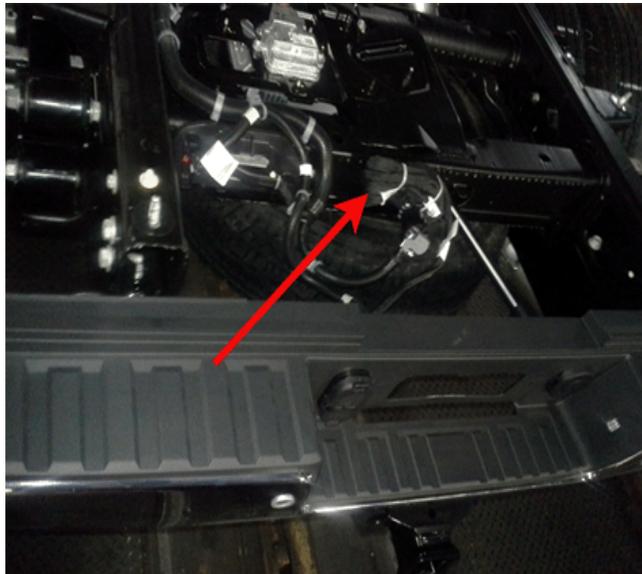
For the 2015 model year, the location has changed to the rear of the pickup box – forward of the rear bumper and attached to the rear frame cross member, as shown below. NOTE: Picture below was taken with the pickup box removed.
